Review of article: **Japanese knotweed (*Fallopia japonica*): An analysis of capacity to cause structural damage (compared to other plants) and typical rhizome extension**

# Japanese knotweed (*Fallopia japonica*): An analysis of capacity to cause structural damage (compared to other plants) and typical rhizome extension (#26989)

# Japanese knotweed (*Fallopia japonica*): An analysis of capacity to cause structural damage (compared to other plants) and typical rhizome extension

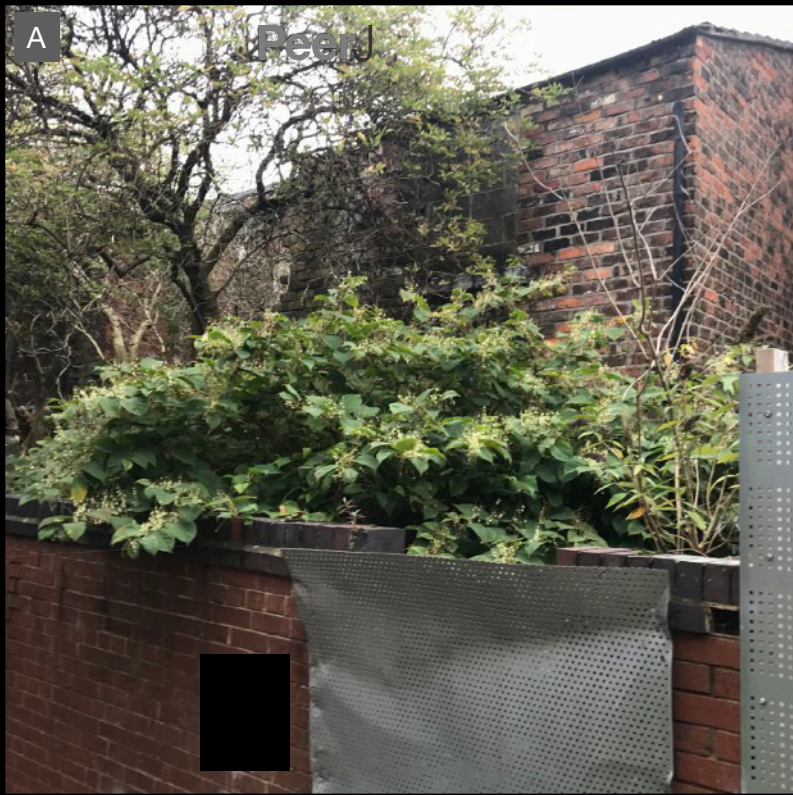
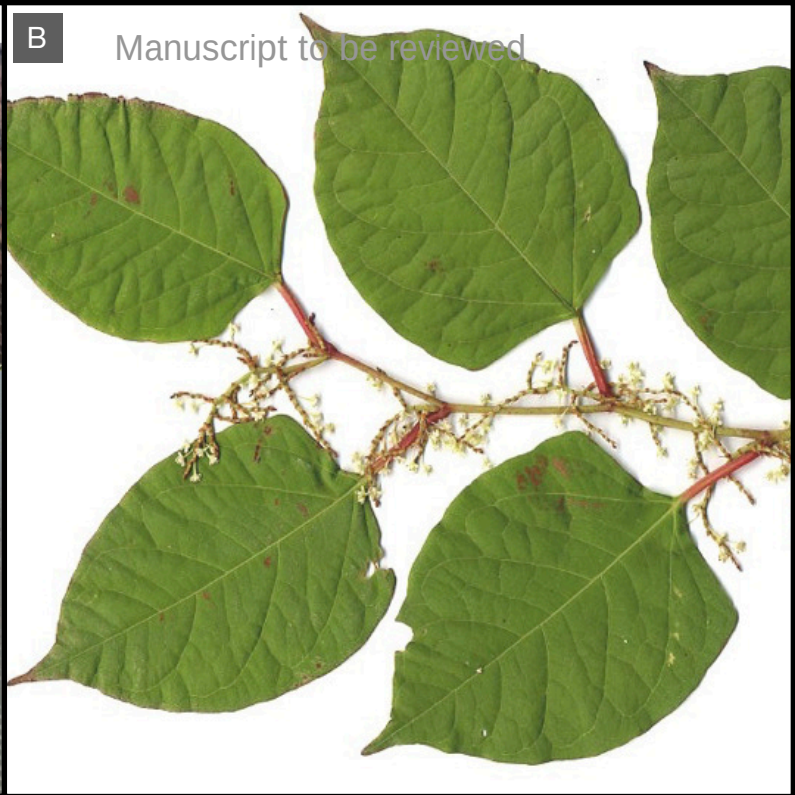
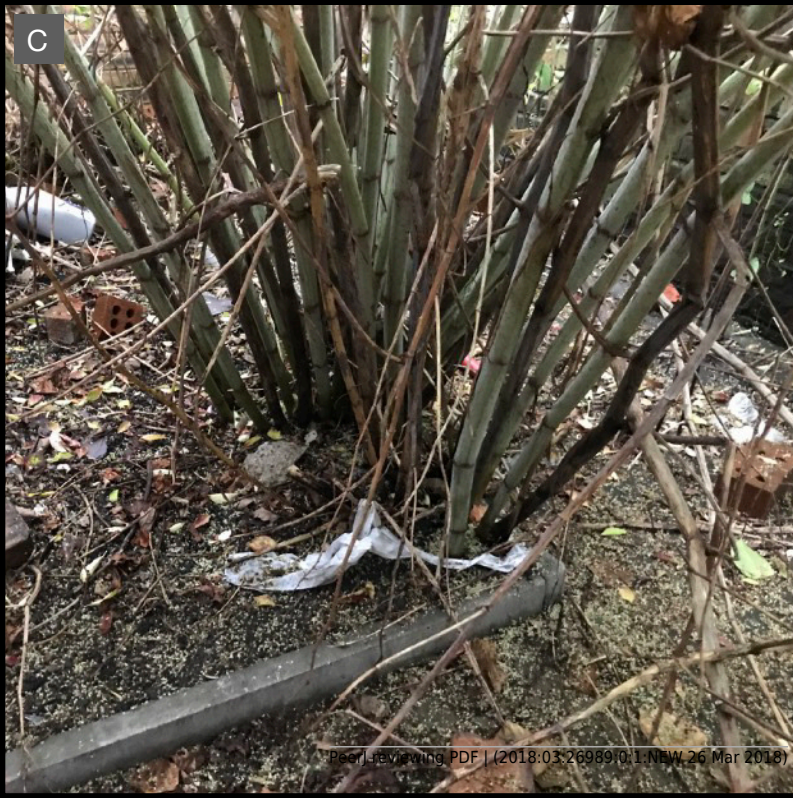
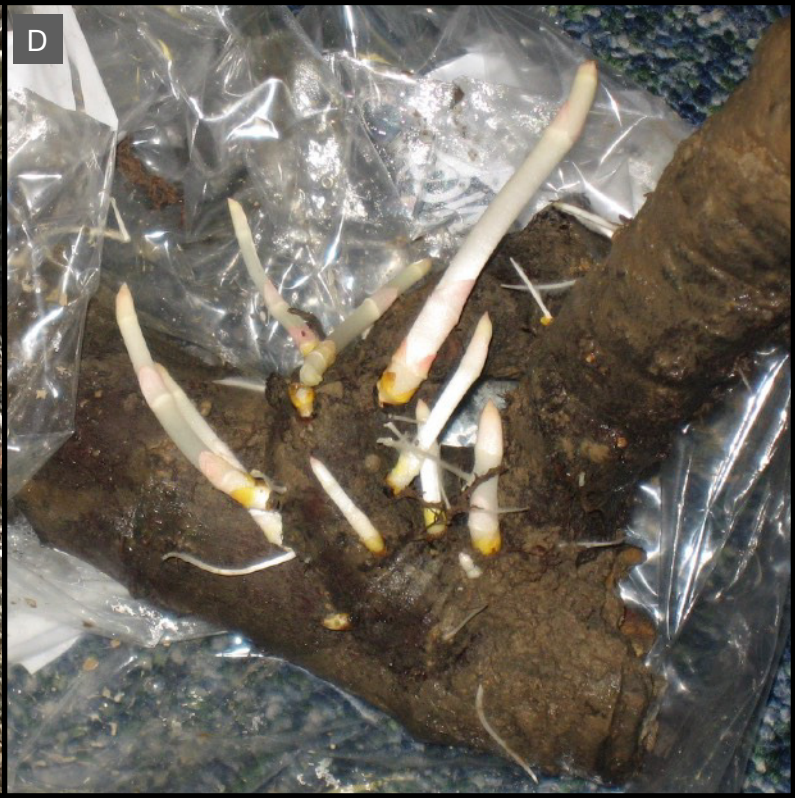
## Figure 2 (on next page)

*Photographs illustrating F. japonica appearance and structure.*

(A) *F. Japonica* growing within the case study area. (B) Specimen of *F. japonica* leaves, stem and inflorescence. (C) *F. Japonica* crown, associated with the plant from panel A. (D) Specimen of *F. japonica* mature rhizome with immature rhizomes emerging.

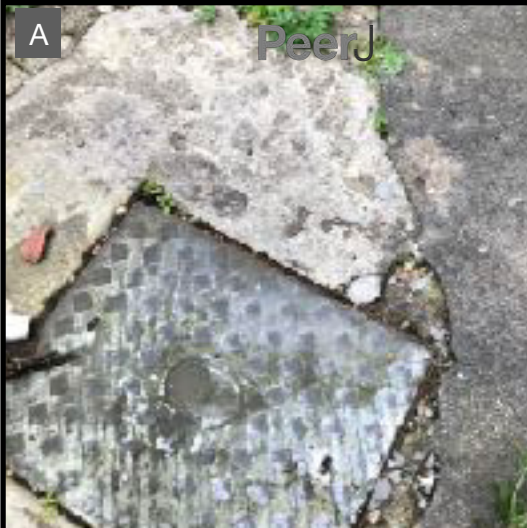
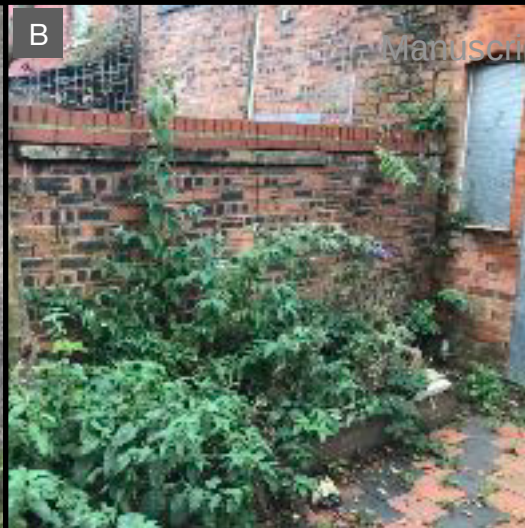
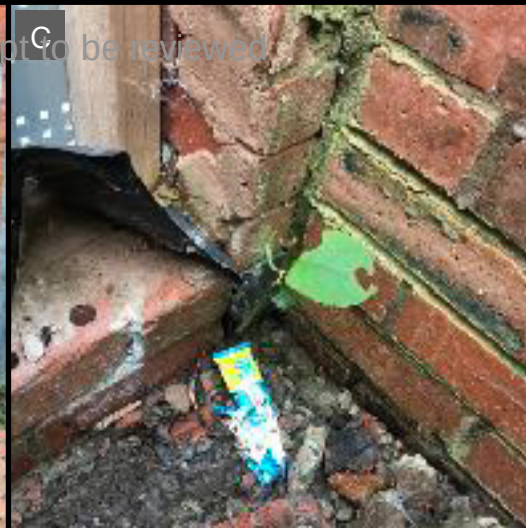
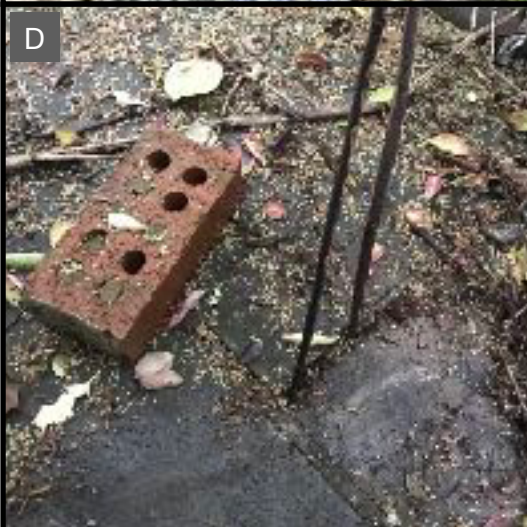
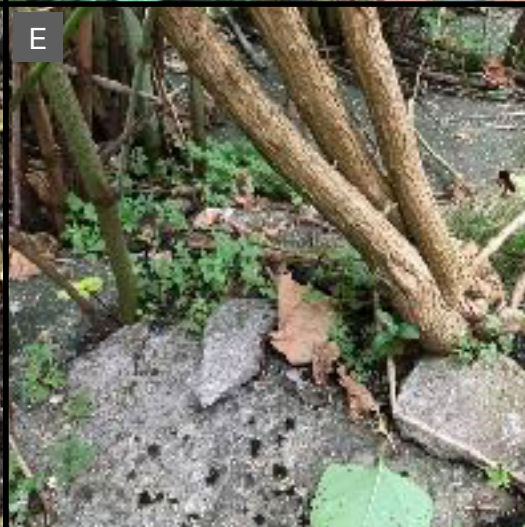
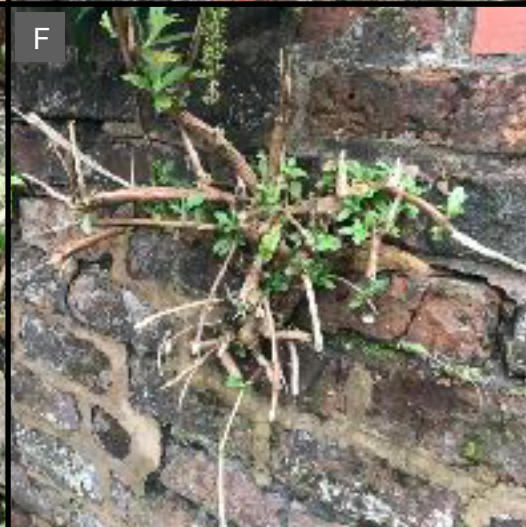
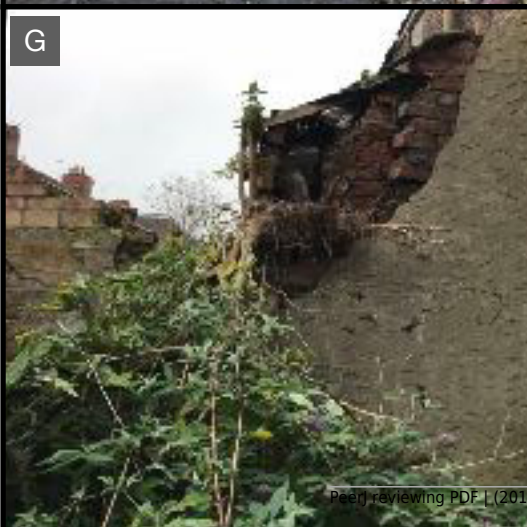
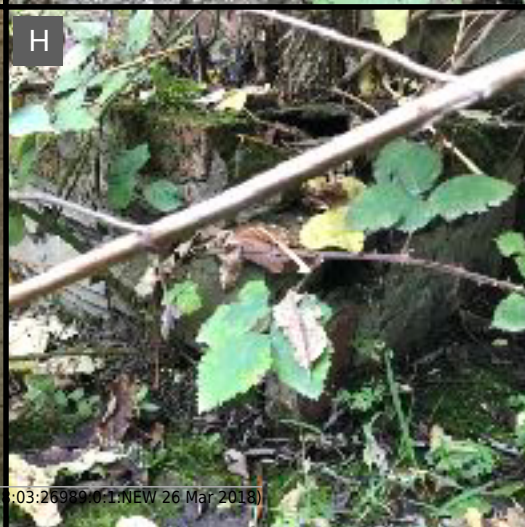
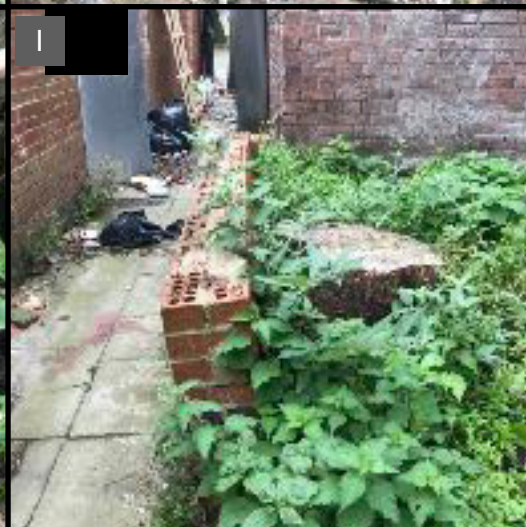
# Figure 3(on next page)

Photographs illustrating examples of the rating scheme that was applied.

(A) Example of non-plant-based wear and tear to hard standing. (B) Rating '0' - *B. davidii* growing in a raised landscaping area, having no discernible impact on undamaged adjacent built structures. (C) Rating '1' - *F. japonica* emerging from existing cracks in paving at the base of a wall, causing no discernible impact away from baseline damage. (D) Rating '2' - *F. japonica* emerging from existing gaps in worn paving, while the gap has not been widened some mortar has been punched aside. (E) Rating '3' - *B. davidii* growing out of a crack in worn concrete hardstanding, with additional cracks forming in the area. *F. japonica* visible in the background emerging from similar cracks in the hardstanding, also exacerbating existing damage but to a lesser extent. (F) Rating '3' - *B. davidii* growing out of cracks in worn brickwork, with additional cracks forming in the area. (G) Rating '4' - *B. davidii* growing out of cracks in worn brickwork. It has found its way between two structures and is facilitating the dilapidation of the wall and pushing out brickwork. (H) Rating '6' *B. davidii* growing behind a small retaining wall and pushing some brickwork over. (I) The remains of a tree stump, which have destabilised the base of what remains of a dilapidated wall.

A survey was conducted on 68 residential properties located on three streets in northern England. The houses on all three streets were built prior to 1900 (CDRC, 2018). All properties have been abandoned for at least ten years and were in a state of disrepair, with most having cracked patios and crumbling brickwork (particularly on boundary walls). *F. japonica* was previously known to be present on properties located on all three streets. An assessment was carried out in September 2017 to determine any constraints that the species might pose to restoration and re-development (see supplementary data 2 for details). These sites represented a close to “worst case” scenario in terms of susceptibility to damage from unchecked plant growth. With this in mind, a survey was conducted to determine presence and associated damage for *F. japonica*, trees, woody shrubs and woody climbers. All damage was compared against a baseline of existing damage that was present due to neglect, weathering and wear and tear over the lifetime of the properties, regardless of plant presence. Where plants were associated with damage to a structure, the damage was quantified based on the scale presented in Table 3 (see also supplemental information 2). Figure 3 presents examples of the rating scheme that was applied.

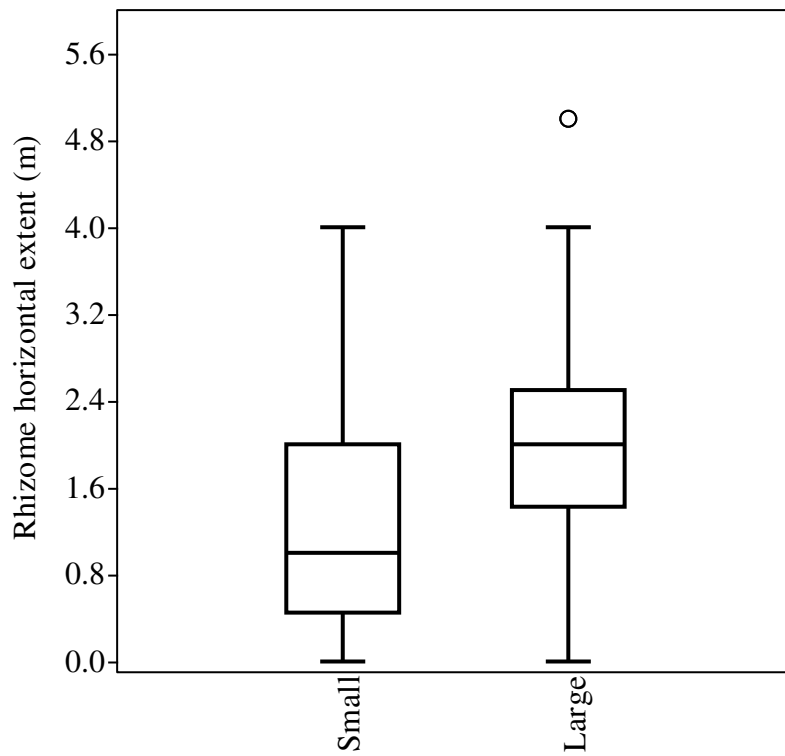
# **Figure 4**(on next page)

Comparison of horizontal rhizome extent between small (4 m<sup>2</sup> or less) and large (greater than 4 m<sup>2</sup>) stands of *F. japonica*.

The box represents the lower 25 percentile, the median value and the upper 25% percentile and the whiskers represent the range of the data. The circle represents an outlier value (greater than two standard deviations away from the median value). Mann Whitney U: U = 412; p < 0.05 (p = 0.01802). N = 21 (small) and 60 (large).

There was a statistically significant difference (Mann Whitney U;  $p < 0.05$ ) in the horizontal extent of *F. japonica* rhizomes between small and large stands, with larger stands found to have

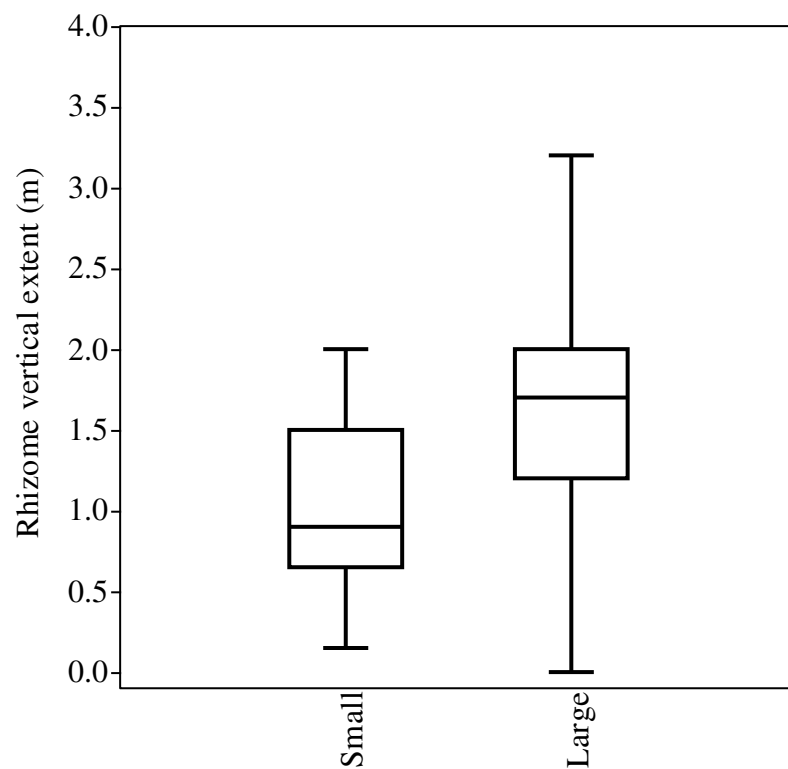
# Figure 5(on next page)

Comparison of vertical rhizome extent between small (4 m<sup>2</sup> or less) and large (greater than 4 m<sup>2</sup>) stands of *F. japonica*.

The box represents the lower 25 percentile, the median value and the upper 25% percentile and the whiskers represent the range of the data. The circle represents an outlier value (greater than two standard deviations away from the median value). Mann Whitney U: U = 260; p < 0.0001 (p = 6.105<sup>e-5</sup>). N = 21 (small) and 60 (large).

There was also a statistically significant difference (Mann Whitney U;  $p < 0.001$ ) between the large and small stands for vertical rhizome extent, with larger stands found to have deeper reaching rhizomes (Figure 5). No records with vertical rhizome extent in excess of 3.5 m were recorded. The small stands had rhizomes with a mean 1.02 m depth and a maximum of 2 m, whereas the maximum vertical extent recorded for the large stands was 3.2 m and the mean was 1.64.
