An assessment of fracture resistance of three composite resin core build-up materials on three prefabricated non-metallic posts, cemented in endodontically treated teeth - An in vitro study

Lalit Kumar, Bhupinder Pal, Prashant Pujari

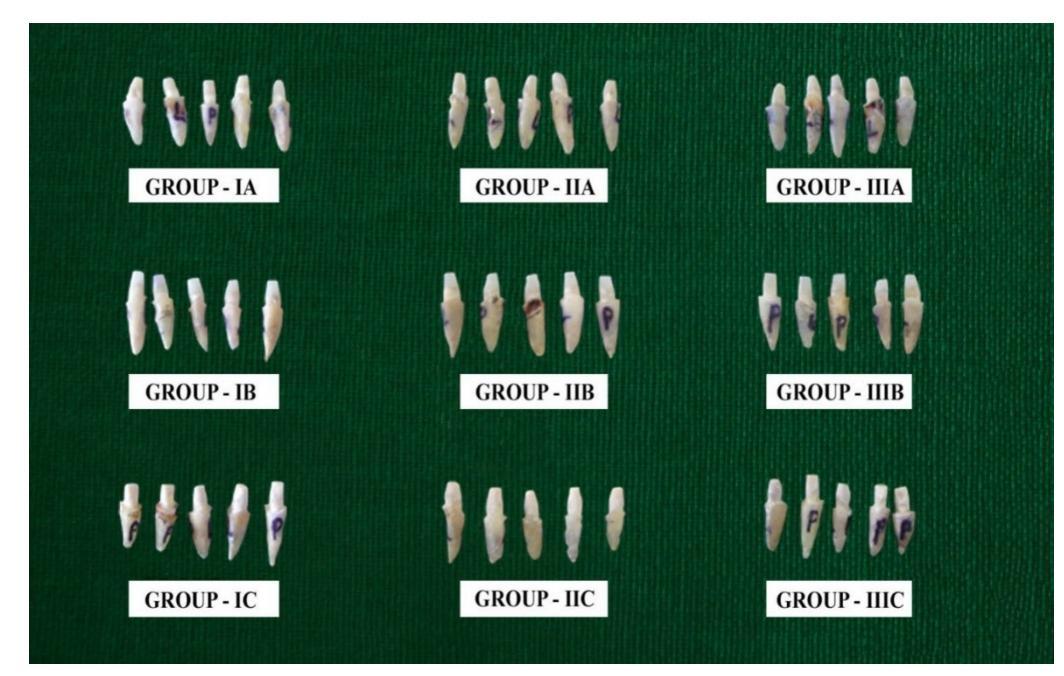
499 Figure 1 Photograph showing samples with core build-ups

144 required to be light cured. In the similar manner all the core build-ups were carried out as 145 mentioned above for the 15 samples using Ti-core and Lumiglass for core build up (Figure-1).

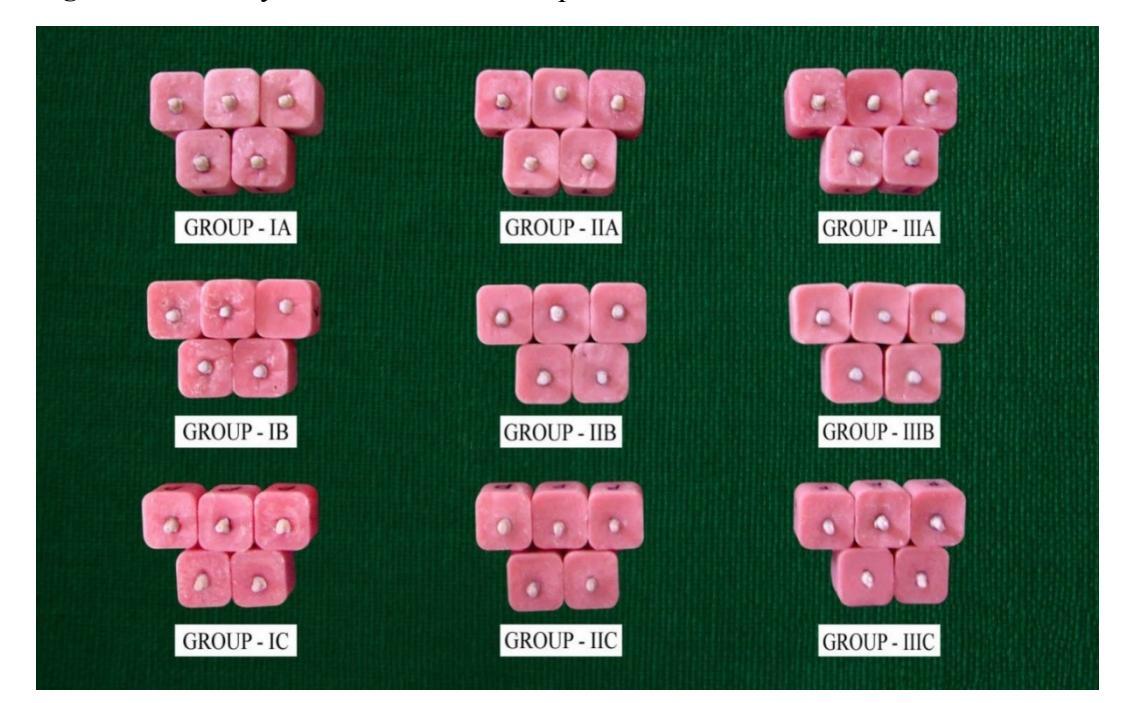
501 Figure 3 The acrylic block with the samples

A split mould was used to mount the teeth in autopolymerising acrylic resin. The teeth were mounted perpendicular to the base of the mould and embedded in the autopolymerising acrylic resin so that the cervical finish line was just above the autopolymerising acrylic resin (Figure 3). All the teeth were mounted in a similar manner.

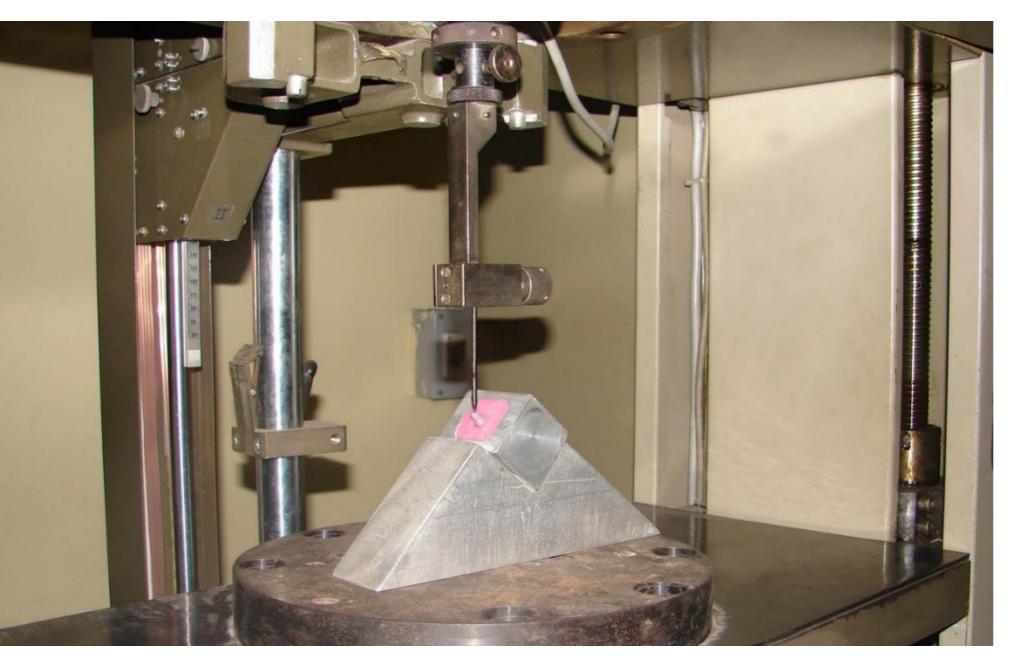
502 Figure 4 Photograph showing samples positioned at 1300 on the Zwick universal load testing503 machine

154 The acrylic block with the samples were placed on the Zwick machine (Figure-4) for 155 testing of the fracture resistance.

For positioning the samples on the Zwick machine a customized mounting fixture was fabricated into which the acrylic blocks fitted perfectly. The fixture also helps to position the samples in such a way that the load could be directed at 130° to the long axis of the tooth (Akkayan B, Gulmez T, 2002).

Each of the sample blocks were fixed to the base of the Zwick machine using the fixture and the tip of the plunger was made to contact the notch on the palatal surface of the core build up. The samples were loaded at a crosshead speed of 0.5mm/min (Fraga RC et al, 1998) until there was a visible or audible sign of failure in the post and core. The site at which the fracture **(Figure-6)** took place was evaluated and the results tabulated. Observations thus obtained were statistically analysed.

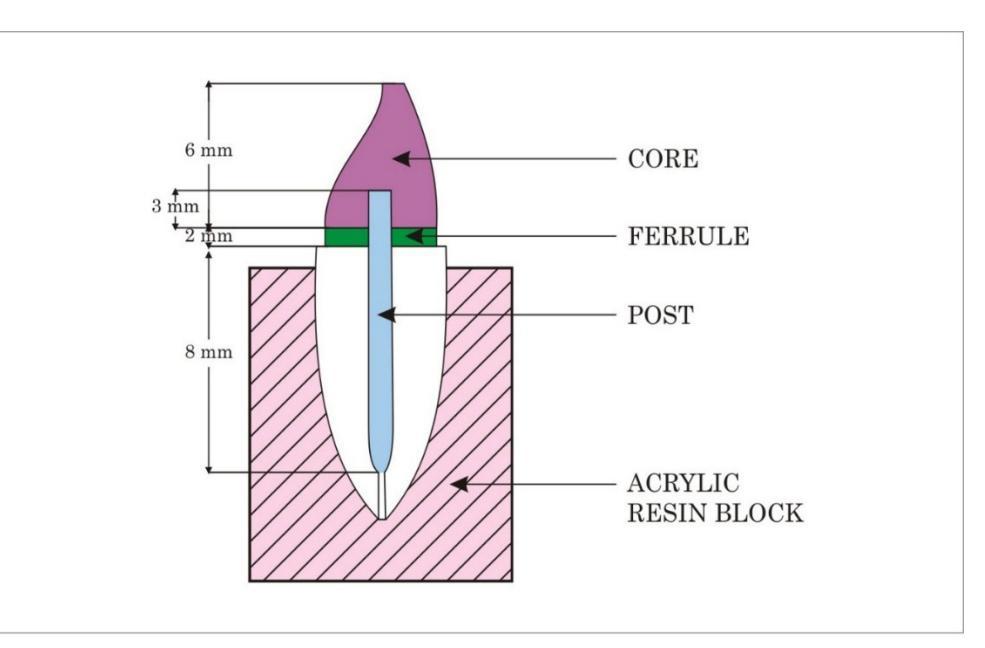
504Figure 5 Photograph showing dimensional representation of post and core foundation

The core build-ups were modified with an air rotor to give the shape of a prepared tooth so as to simulate clinical conditions. The height of the core from the cemento-enamel junction was 8 mm (Brandal JL, Nicholls JI, Harrington GW, 1987). It was observed that the incisal edge of lower teeth contacted the palatal surface of the maxillary central incisor 1mm below the incisal edge of the core (Dilmener FT, Sipahi C and Dalkiz M, 2006). Thus, this point was standardized for load application by preparing a notch on the palatal surface of the core 1mm below the incisal edge. These samples were mounted on acrylic blocks.

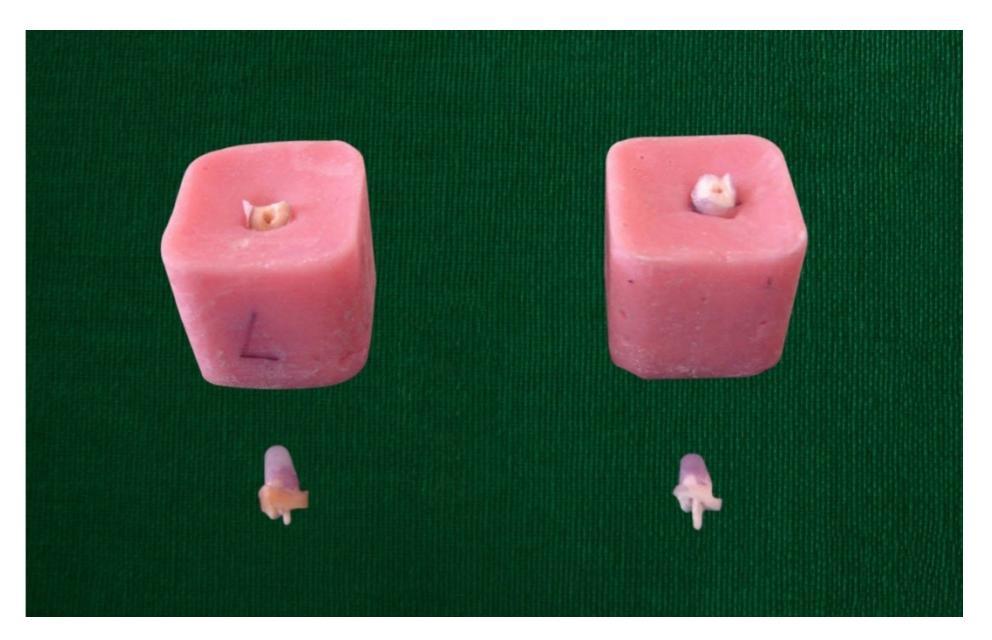
505Figure 6 Photograph showing fractured samples

181 Student's unpaired't' test was also used to analyse and compare each group with the other 182 groups individually, and decide whether their comparisons were statistically significant as listed 183 in **Table-4**. Fracture patterns were either horizontal, oblique, some involving the core, some 184 involving the post and tooth structure, some with debonding of post and core and some with a 185 combination of above types. However an attempt is made to classify these fractures into two 186 groups as shown in **Table -5 and 6**. They are –

1. Restorable or Salvageable Fractures -

188 Fractures that have occurred above the CEJ, or oblique fractures that cross below the CEJ189 with sum amount of coronal dentin, and the oblique fracture ends in the cervical 1/3rd of the root.

190 2. Non-Restorable or Non-Salvageable Fractures –

191 Fractures occurring below the CEJ with no coronal tooth structure remaining.
