# An assessment of fracture resistance of three composite resin core build-up materials on three prefabricated non-metallic posts, cemented in endodontically treated teeth - An in vitro study

Lalit Kumar, Bhupinder Pal, Prashant Pujari

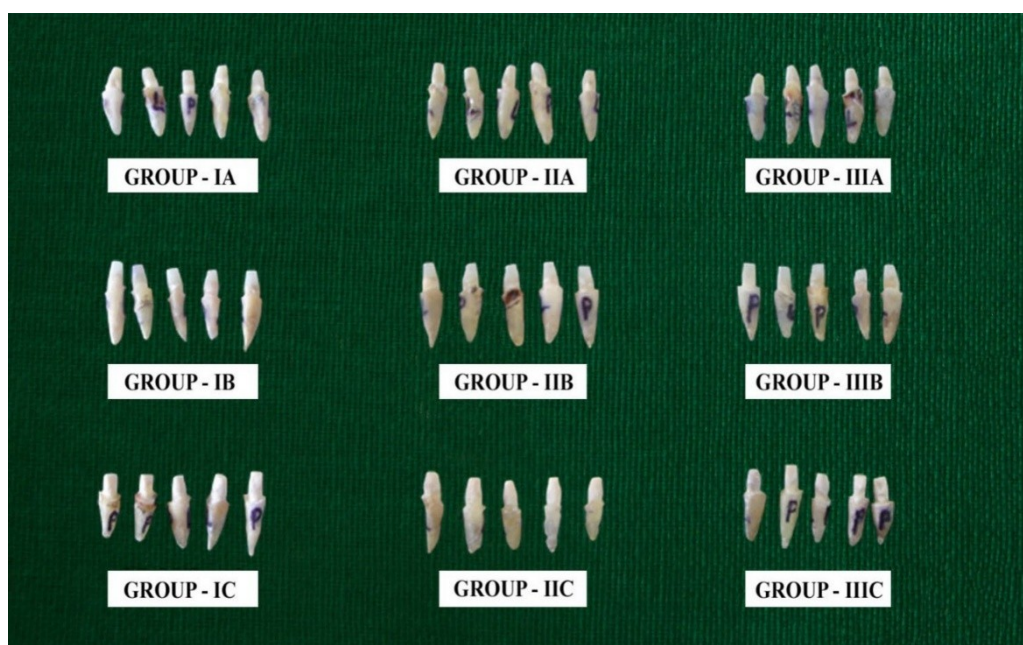
**Figure 1** Photograph showing samples with core build-ups

The core build-ups were modified with an air rotor to give the shape of a prepared tooth so as to simulate clinical conditions. The height of the core from the cemento-enamel junction was 8 mm (Brandal JL, Nicholls JJ, Harrington GW, 1987). It was observed that the incisal edge of lower teeth contacted the palatal surface of the maxillary central incisor 1mm below the incisal edge of the core (Dilmener FT, Sipahi C and Dalkiz M, 2006). Thus, this point was standardized for load application by preparing a notch on the palatal surface of the core 1mm below the incisal edge. These samples were mounted on acrylic blocks.

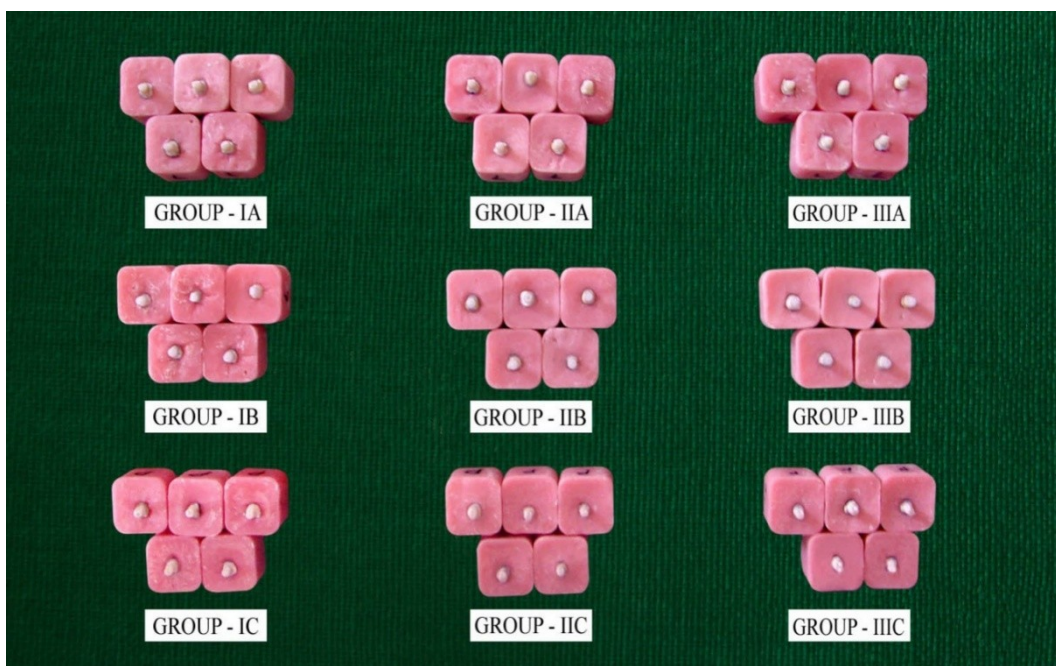
501 **Figure 3** The acrylic block with the samples

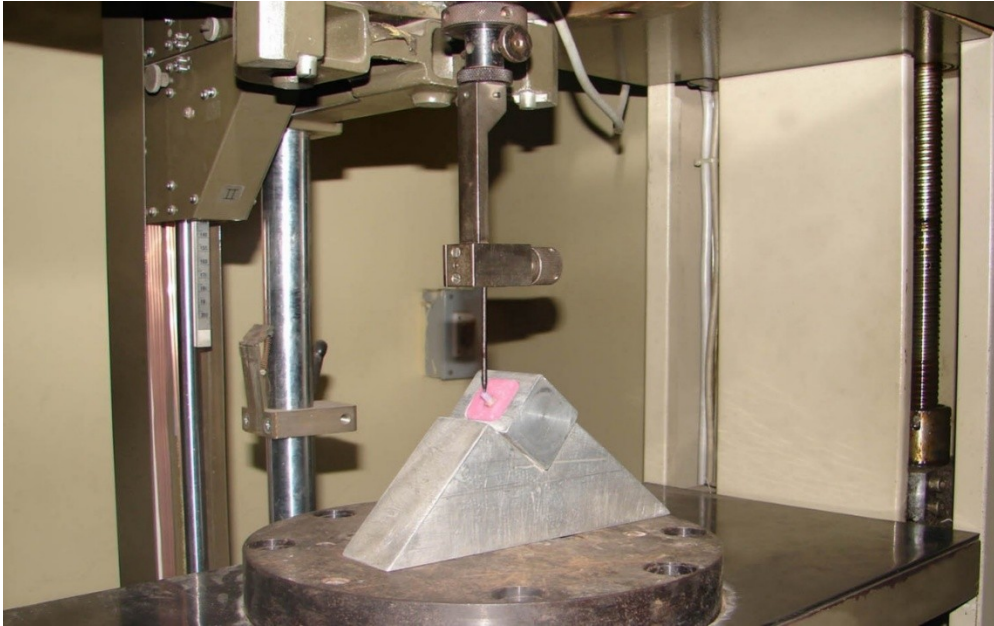
502 **Figure 4** Photograph showing samples positioned at 1300 on the Zwick universal load testing  
503 machine

The acrylic block with the samples were placed on the Zwick machine (**Figure-4**) for testing of the fracture resistance.

Each of the sample blocks were fixed to the base of the Zwick machine using the fixture and the tip of the plunger was made to contact the notch on the palatal surface of the core build up. The samples were loaded at a crosshead speed of 0.5mm/min (Fraga RC et al, 1998) until there was a visible or audible sign of failure in the post and core. The site at which the fracture (**Figure-6**) took place was evaluated and the results tabulated. Observations thus obtained were statistically analysed.

Load was applied by a Zwick universal load testing machine at a crosshead speed of 0.5 mm/min (Fraga RC et al. 1998). Failure threshold was defined as a point at which the sample could no longer withstand load and fracture of material, tooth or root occurred. From the observation obtained statistical analysis was performed.

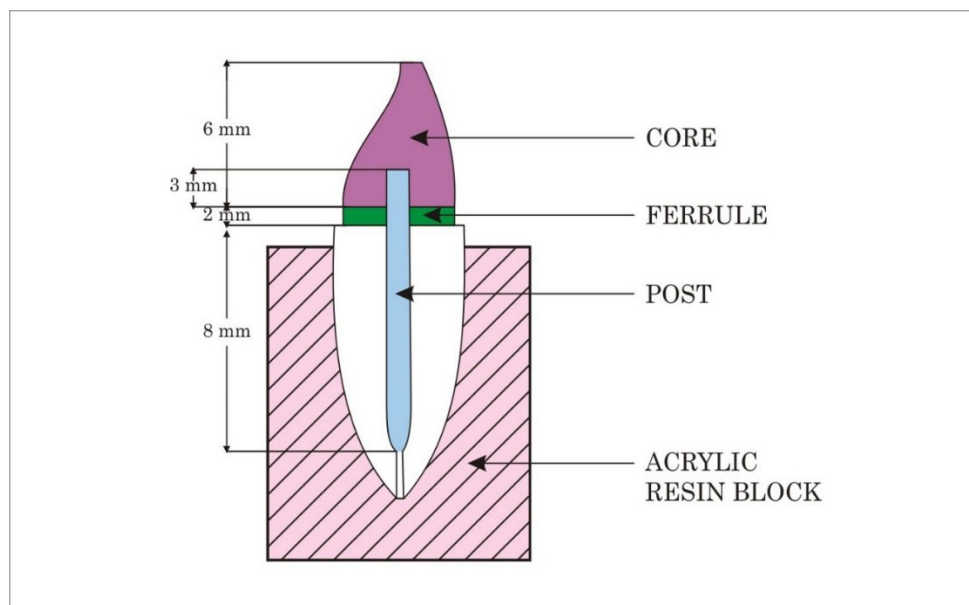
504**Figure 5** Photograph showing dimensional representation of post and core foundation

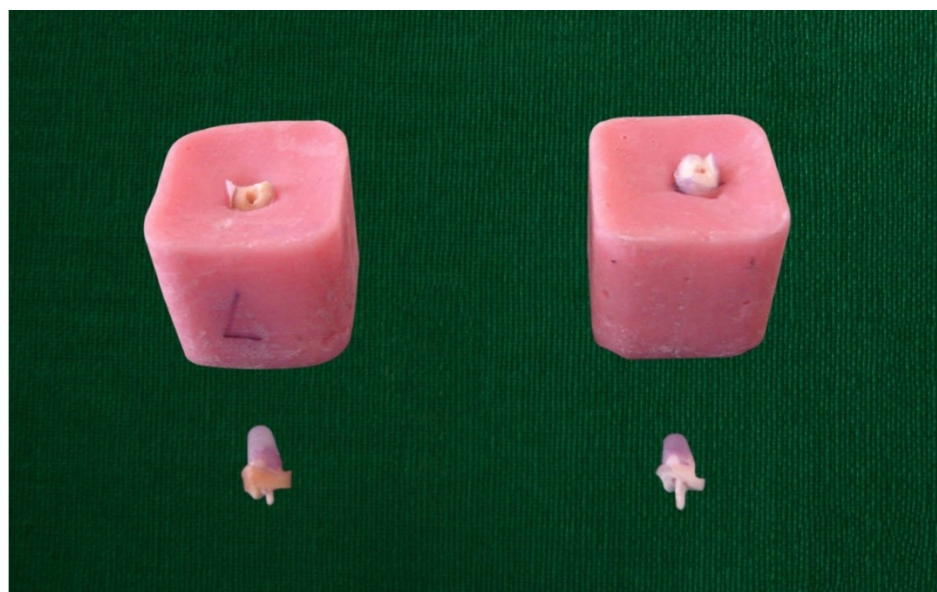
505**Figure 6** Photograph showing fractured samples

Student's unpaired 't' test was also used to analyse and compare each group with the other groups individually, and decide whether their comparisons were statistically significant as listed in **Table-4**. Fracture patterns were either horizontal, oblique, some involving the core, some involving the post and tooth structure, some with debonding of post and core and some with a combination of above types. However an attempt is made to classify these fractures into two groups as shown in **Table -5 and 6**. They are –

#### 1. Restorable or Salvageable Fractures -

Fractures that have occurred above the CEJ, or oblique fractures that cross below the CEJ with sum amount of coronal dentin, and the oblique fracture ends in the cervical 1/3rd of the root.

#### 2. Non-Restorable or Non-Salvageable Fractures –

Fractures occurring below the CEJ with no coronal tooth structure remaining.
